Execution troubles at EPS construction sites of local highway

Takeshi Chiyoda: Mitsubishi Chemical Foam Plastic Corporation

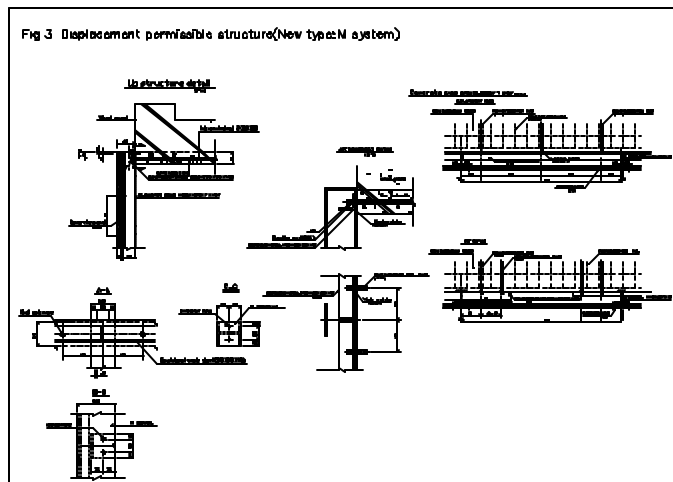
Refer to Photo 1.

Steel supports (H-section steel) for wall face members were deformed and damaged by the incomplete construction of the displacement permissible structure.

The defective displacement permissible structure that was constructed by a civil engineering contractor who did not understand the structures constructed by the EPS method did not function well, and this caused to deform steel supports, crack upper floor slabs and damage the structure itself, and consequently deform the whole EPS banking. As a part of the solutions, it is now planned that more detailed working instructions will be given to civil engineering contractors, and that the displacement permissible structure will be replaced with that which may be constructed even by those who do not understand the necessity of the structure. See Fig. 3, Photo.3 and Photo.4

‡ Wall deformation due to H-section steel deformation

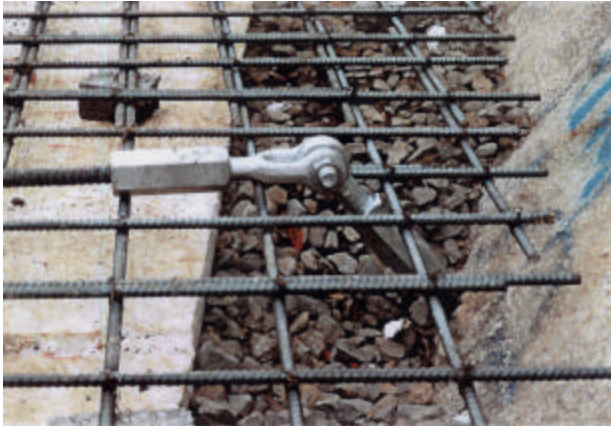
Photo.3 ‡ ‡ ‡ Execution failure of Displacement Permissible Structure

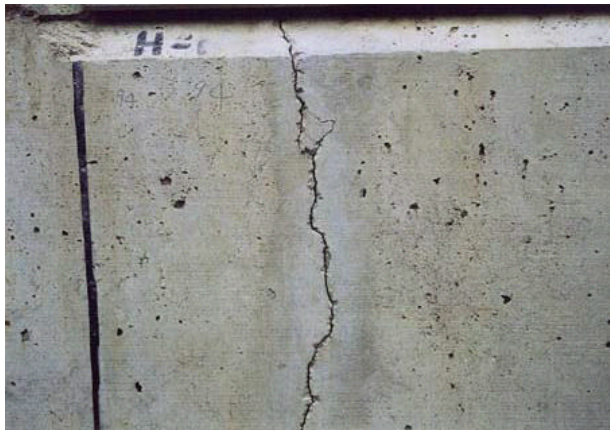
As one of the reasons for the excessive settlements of the EPS banking caused before its completion, it was recently reported that in the work section where a large structure such as bridge was being constructed, the constructors who did not understand the allowable stresses of EPS blocks had run heavy machines directly over the just-installed upper floor slabs of the EPS banking or over the spread subbase course materials of 30cm in thickness, as shown in Fig. 5, to cause the excessive deformations of upper EPS blocks and the excessive subsidence of the EPS banking. This report describes the onerous case that the bridge constructors suppressed the fact that they had run large-sized heavy machines over EPS blocks, and made it difficult to be revealed, while the Owner pointed out the defects of EPS blocks and demanded the constructors to take countermeasures. To cope with such a case, it is imperative to cure the installed upper floor slabs, and strengthen the guard system to prevent heavy machines from running over the pavement not yet reaching the minimum allowable thickness. Refer to Fig. 5 and Photo 5.

Photo.5 该该该 Execution failure of H section steel

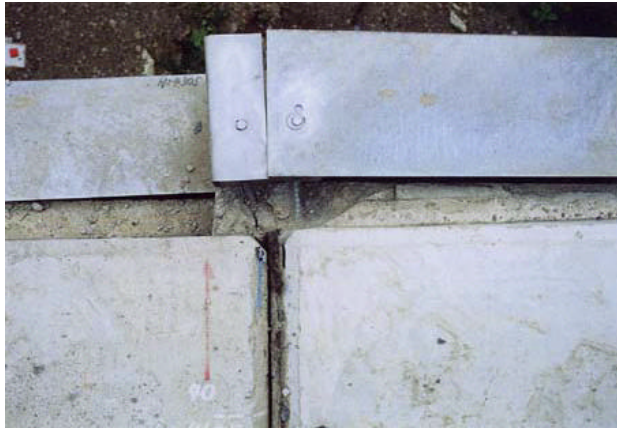
Photo.6 ㄱ ㄱ ㄱ Execution failure of movable joint part of EPS anchor
