# **LONG TERM PERFORMANCE AND DURABILITY OF EPS AS A LIGHTWEIGHT FILLING MATERIAL**

Tor Erik Frydenlund<sup>1</sup> and Roald Aabøe<sup>2</sup>

## **ABSTRACT**

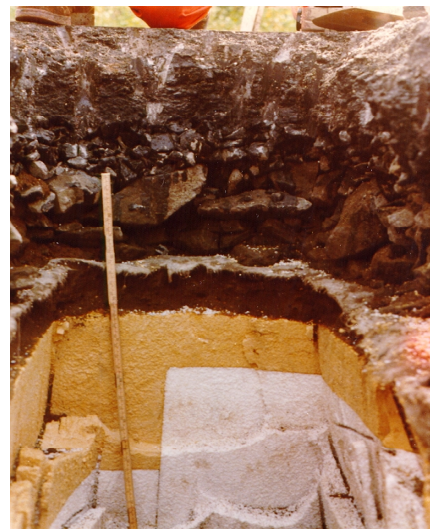
**Figure 2. Excavation of the first EPS embankment at Flom bridge**

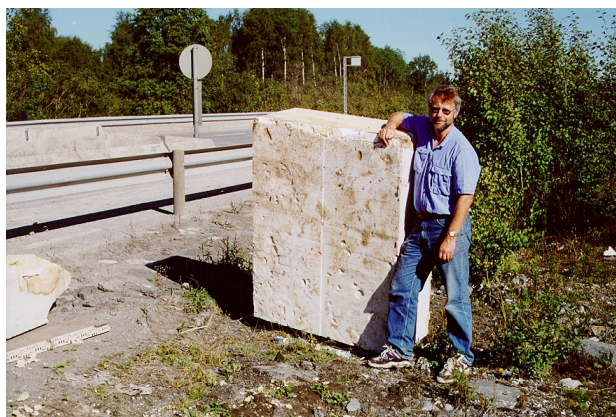
**Figure 3. Excavation of a 24 years old EPS block from the first EPS embankment at Flom bridge**

This one test was performed on samples taken from the first fill shortly after it was completed in 1972, and is more an indication of variations in material quality of EPS with the production process used at that time. Still the observed value is within the accepted statistical variations in material strength.

From figure 4 it may also be observed that the majority of tests show values of compressive strength in relation to unit density above that of a normal quality material. Although it is of course impossible to make exact comparisons between material strength at the time of construction and some time afterwards since tests cannot be performed on the same specimen twice, the results indicate clearly that there are no signs of material deterioration over the total time span of 24 years. If a change tendency is to be noted, this would go towards a

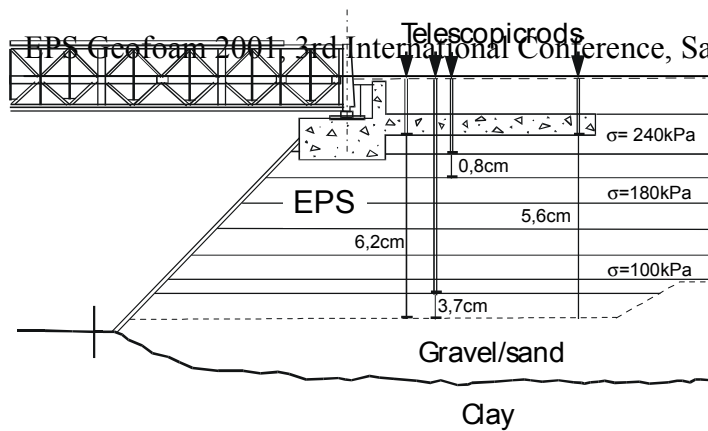
Figure 12. Deformations in EPS embankment at Løkkeberg.

After 12 years in service measurements show only small deformations 6 cm (1,3 % of the EPS height) in the EPS embankment. Most of the deformation occurred during the construction period and only minor creep effects have been measured. Creep deformations as an average and creep deformations for the lowest EPS layer (6,5 % of the layer thickness) are shown in fig. 13 for a period of 10 years.

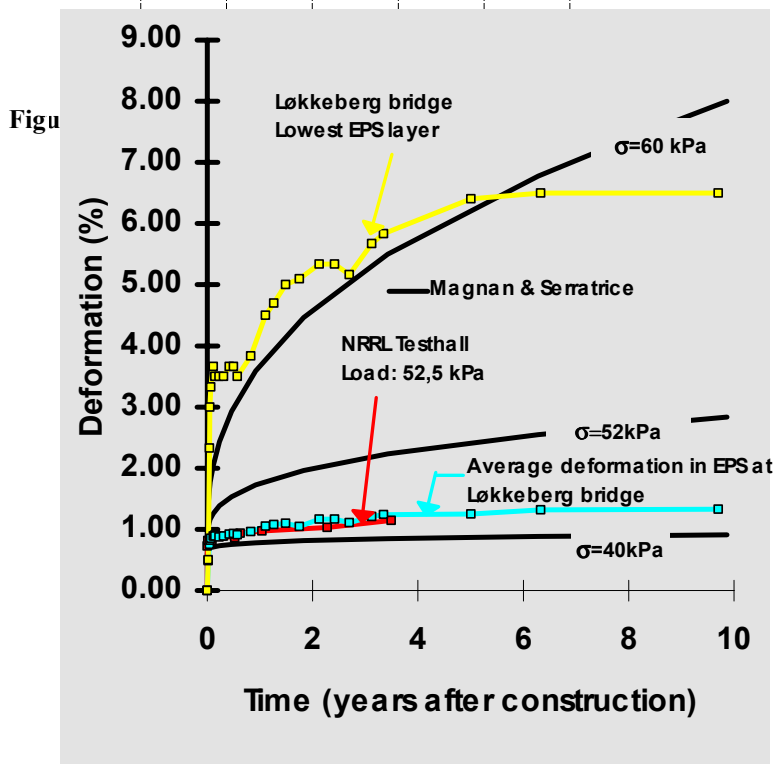
The figure clearly shows that the average deformation at the Løkkeberg bridge is small and slightly over 1 % of the total fill height. Also observed creep effects are almost negligible for the total fill although deformations in the bottom block layer was 4 % initially and later creep effects amount to further 2.5 %. Creep deformations in the bottom layer correspond with the theoretical values the first 5 years but has later slowed down to almost zero.

Figure 14. Creep deformations in EPS.

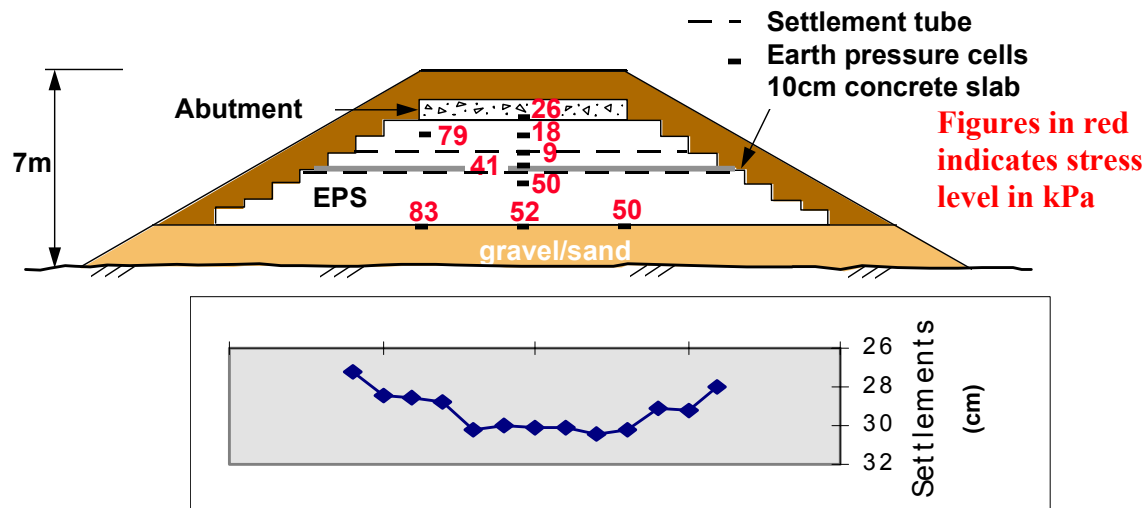
Figure 15. Løkkeberg bridge. Observed stress distribution and settlements in the cross section after 10 years in operation.

In the upper part of the fill (with a higher material strength) lower stress than expected has been measured in a zone under the central part of the embankment. One explanation could be some kind of arching effect due to large subsoil settlements in the middle of the embankment. This can clearly be seen in fig. 15 where the measurements from the settlement tube are shown. In the lower part of the fill it is difficult to explain load concentration and deformation in

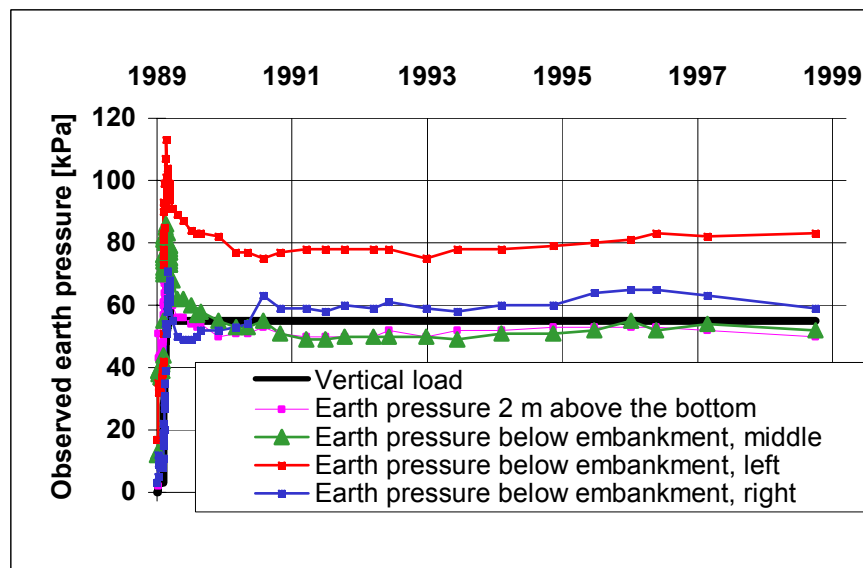
Figure 16. Long term measurements of earth pressure at Løkkeberg bridge

Long term measurements from 3 earth pressure cells below the fill and one situated 2 m higher up have been plotted in fig. 16. During the first year of operation a stress decrease of 15 - 30 % was observed. Later only small variations with time have been observed. Measured stresses corresponds well with the theoretical vertical load in the lower part of the EPS fill.

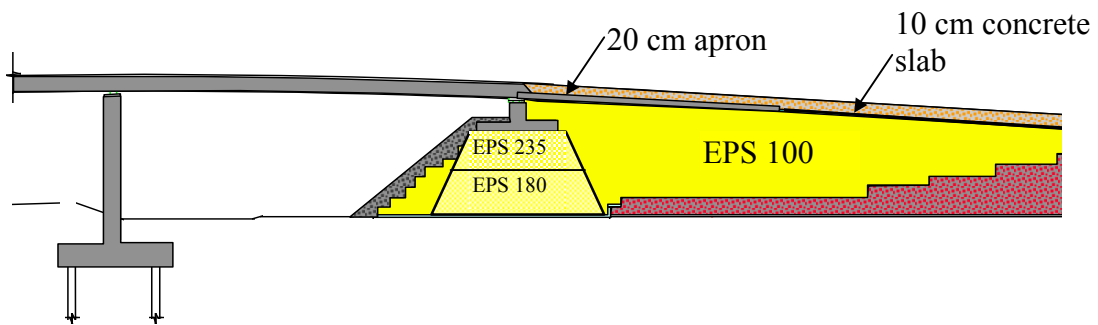
Some 2 years after completion it became evident that the bearing capacity of the soil beneath the abutments had been exceeded as excessive settlements occurred and the abutments inflicted damage to the bridge deck. Deformation monitoring was initiated and it soon became clear that immediate repair measures had to be initiated. Since settlement caused by the approach fills was the main problem, it was decided to reduce the load on the subsoil by some 30 – 40 kN/m² in order to re-establish the initial subsoil stress conditions. This involved replacing parts of

**Figure 19. Supporting bridge abutments directly on EPS, Hjelmungen bridge, Norway**

the fills with EPS blocks and supporting new bridge abutments directly on the EPS. The repair design is indicated in figure 19.

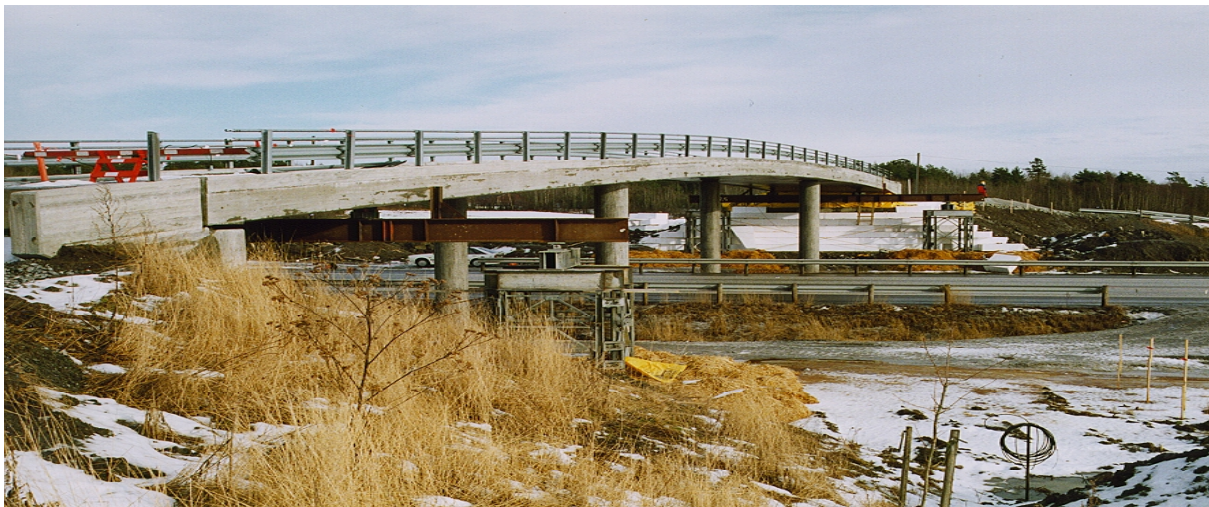
**Figure 20. Temporary support of abutments at Hjelmungen**

Repair works were initiated in December 1995 and completed in the spring of 1996. One abutment was treated at a time while the bridge deck was provided with a temporary support as shown in figure 20. Thickness and densities of the original filling materials were recorded as they were removed in order to have accurate data for control of load and settlement calculations. After removing the old abutments, the concrete piles were inspected regarding possible damage before being cut at ground level. No pile damage was observed. Construction of the EPS fills could then start. In this case three different qualities of EPS were utilized. In the zone directly beneath the bridge abutment, as indicated by the trapezoidal shaped lines in figure 19, a material quality of  $\sigma = 235$  kPa was specified for the first three block layers beneath the bottom slab of the abutment. Further down a material quality of  $\sigma = 180$  kPa was

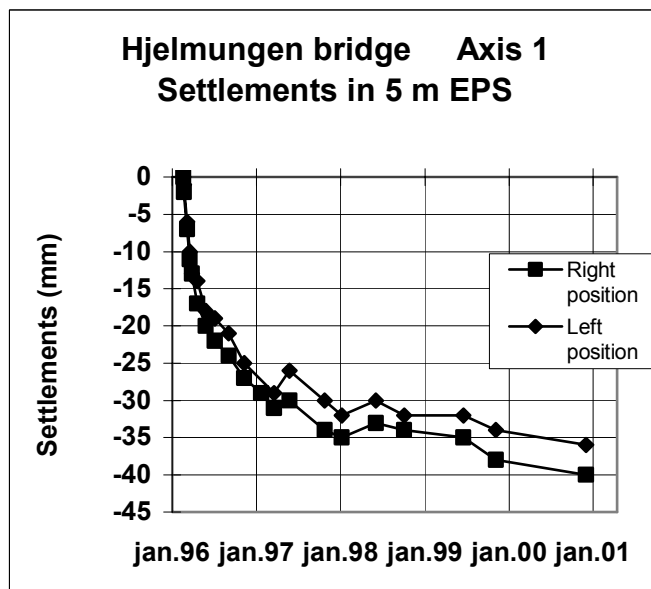
In order to monitor the behaviour of the reconstructed bridge both settlement and stress gauges have been installed. The different types of gauges and their locations in relation to the bridge abutment are indicated on the cross section in figure 21. Prior to reconstruction the settlement rates of the adjoining fills were observed to be 100 mm/year and constant. After reconstruction the settlements have nearly been halted as shown on figure 22.

**Figure 22. Measured settlements at Hjelmungen**

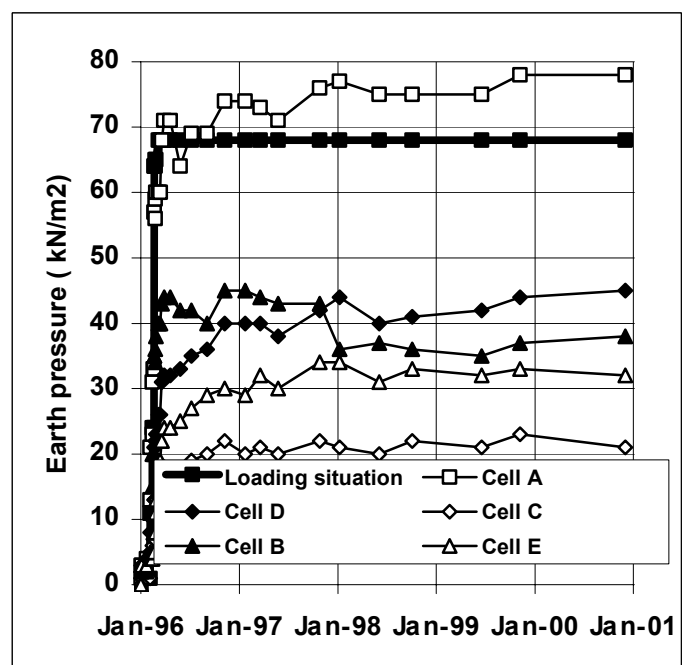
Observed stresses beneath the EPS fill indicate a higher stress under the central part of the abutment than under the edges as shown in figure 23. Calculated loads on the abutment are indicated by the heavy line drawn in the diagram. Problems associated with providing enough lifting force when jacking up the bridge deck may, however, indicate that reaction forces from the bridge deck are somewhat higher than calculated.

**Figure 23. Earth pressure below EPS layer at Hjelmungen**
