BEHAVIOUR OF AN OLD EPS LIGHT-WEIGHT FILL AT VAMMALA, FINLAND

Seppo Saarelainen¹ and Heikki Kangas²

ABSTRACT

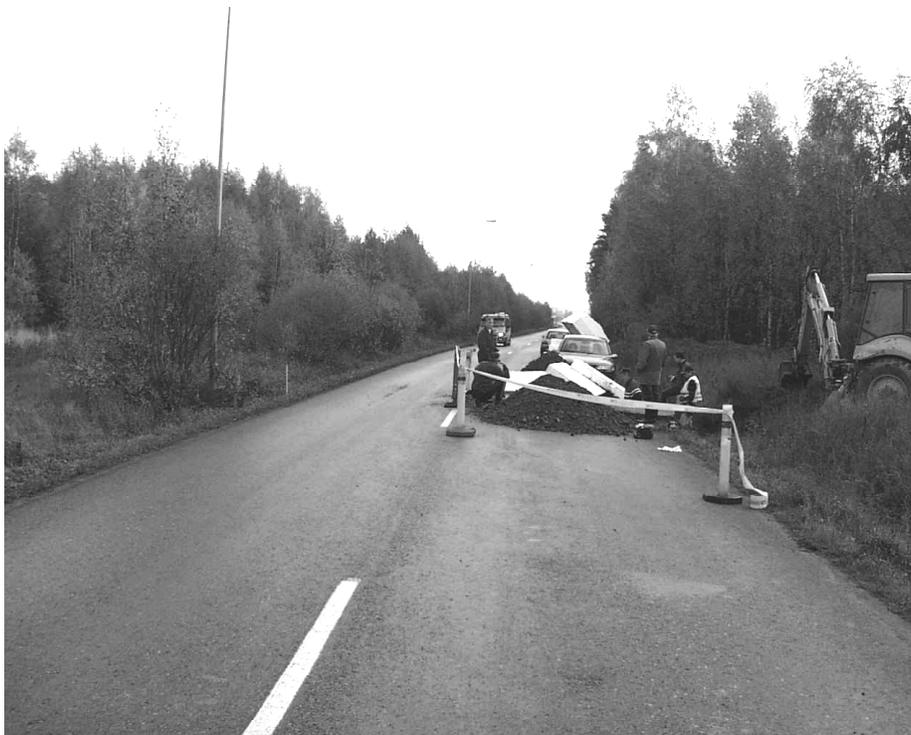
During the excavation, the ground water level was at near the top of EPS. The pit was excavated early in autumn, when the water table was relatively low. The exposed surface of EPS was visually intact and undamaged. Some local dents were detected, caused by crusher-run stones (Figs 2, 3a and 3b). Large samples of fill blocks were taken for further laboratory testing.

Fig. 3a. The test site.

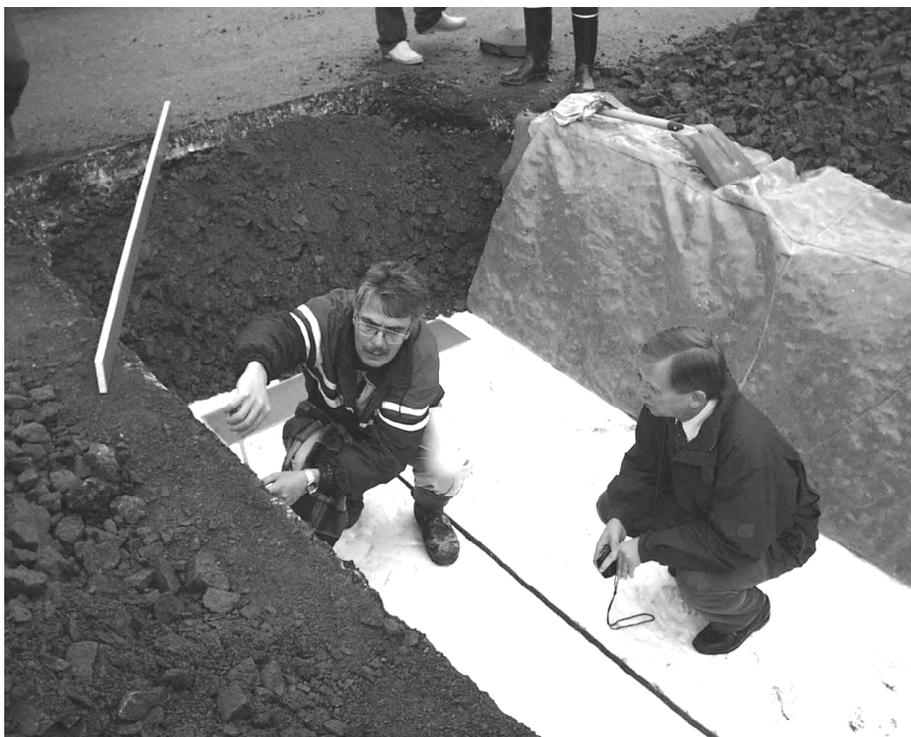
Figures 3b. Exposed EPS-surface in the test pit on Pesurinkatu.
