# **LONG TERM PERFORMANCE AND DURABILITY OF EPS AS A LIGHTWEIGHT FILLING MATERIAL**

Tor Erik Frydenlund<sup>1</sup> and Roald Aabøe<sup>2</sup>

## **ABSTRACT**

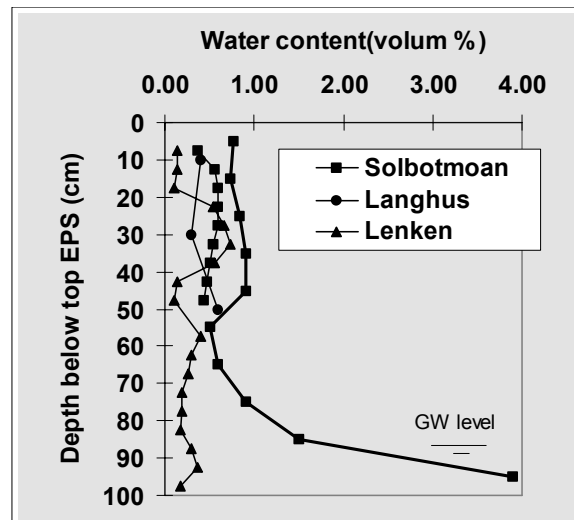
Figure 5. Typical drained situation from 3 EPS fills

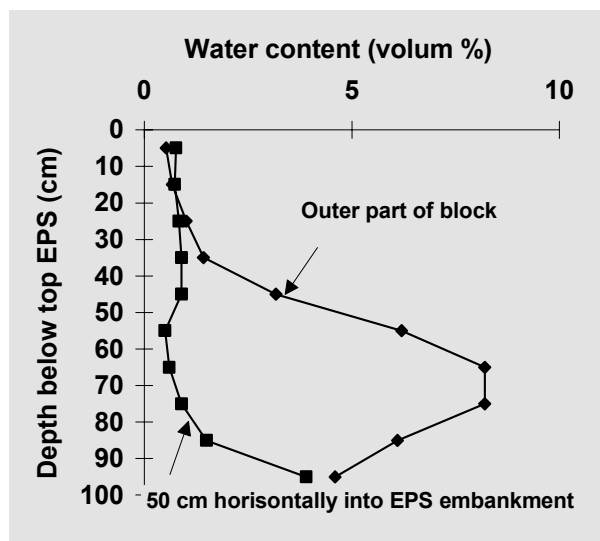
Furthermore there is hardly any change in the water content with time. Samples retrieved from the outer parts of blocks facing the surrounding soil, may have a higher water content as may be seen from figure 6. But only 500 mm further into the block the water content is again below 1 % by volume. So the average density of drained fills therefore has values of  $\rho < 30 \text{ kg/m}^3$ . This is well below the specified design value for such fills.

Figure 6. Horizontal gradient of water in EPS.

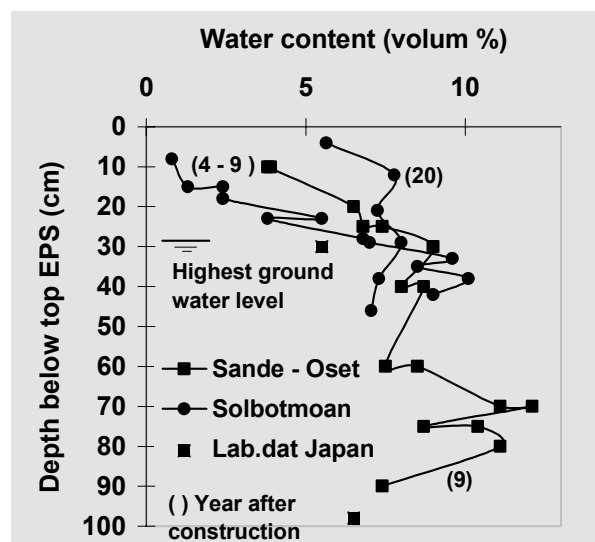
In blocks, which are periodically submerged, water contents of up to 4 % by volume have been measured. In permanently submerged blocks measured water contents have reached values close to 10 % by volume with some increase over the years fig. 7. Further increases above 10 % by volume are, however, not to be expected. For submerged fills the average density is therefore of the order of  $\rho = 90 - 95 \text{ kg/m}^3$  after some 20 years in the ground. The water content decreases rapidly above the water table and show values for drained conditions only some 200 mm above the highest water level.

Figure 7. Typical water content in submerged EPS blocks

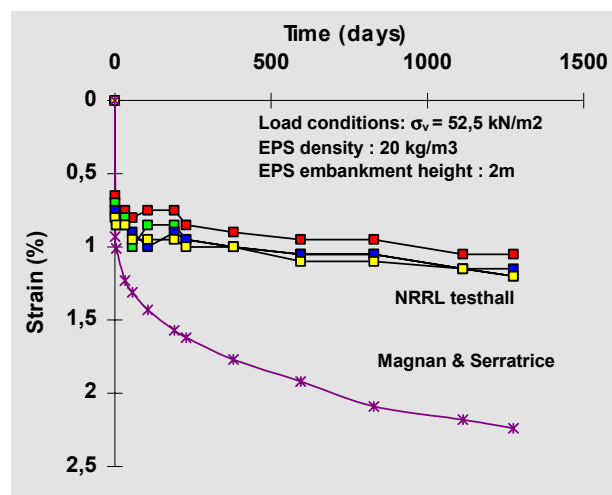
In a laboratory test at the Norwegian Road Research Laboratory (now the Road Technology Department) a test fill of height 2 m with normal size blocks and a compressive strength  $\sigma = 100$  kPa has been loaded to a value of  $q_{dw} = 52.5$  kPa and the resulting deformations observed over a period of 3 years (figure 8). The results are shown in fig. 9 together with calculated deformations to be expected according to the theories introduced by Magnan & Serratrice.

As may be seen the observed deformations are only about half of the calculated values and creep deformations with time are also much smaller.

Figure 9. Deformation / creep in the test fill

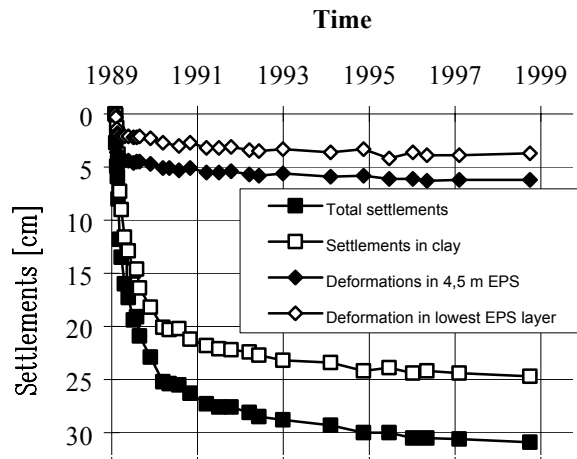
After 12 years in service measurements show only small deformations 6 cm (1,3 % of the EPS height) in the EPS embankment. Most of the deformation occurred during the construction period and only minor creep effects have been measured. Creep deformations as an average and creep deformations for the lowest EPS layer (6,5 % of the layer thickness) are shown in fig. 13 for a period of 10 years.

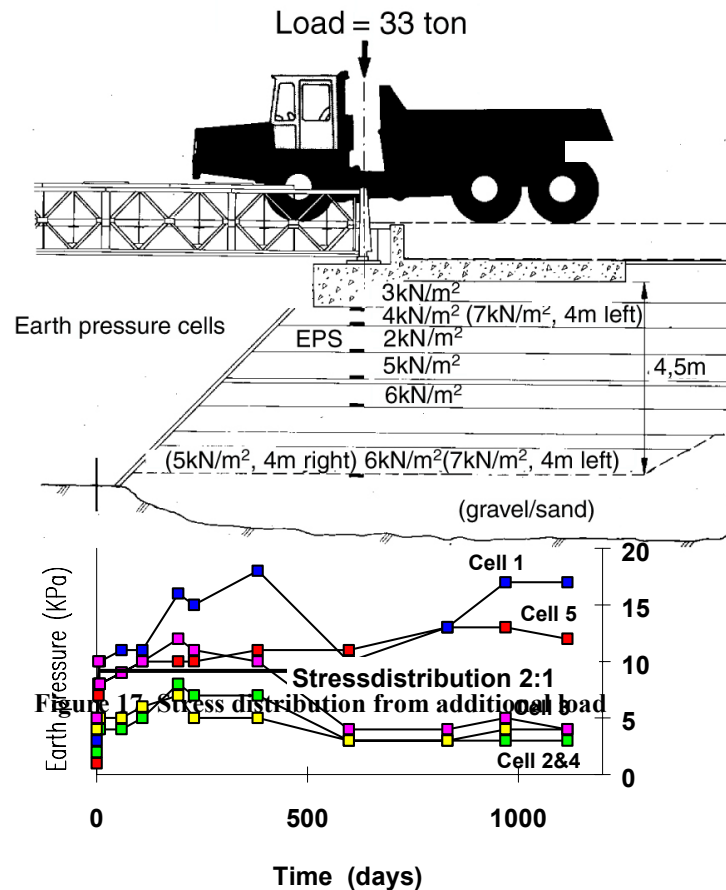
Figure 18. Stress distribution measured in the test hall (fig. 8)

Attempts have been made to evaluate the stress distribution in EPS blocks based on stress observations from the test hall experiments and stress observations at the Løkkeberg bridge. Stresses between blocks are of course difficult to measure and the results obtained vary quite a bit. In general measured stresses are, however, relatively low and indicate that the outer perimeter of the stress bulb may lie within a slope with a gradient 2:1 measured from the outer edge of the loading area. However, depending on the stiffness of the loading area and possible load eccentricities, local stress concentrations may occur. In figure 18 the stress level at the bottom of the fill with distribution gradient 2:1 is indicated with a black line and may be compared to the stress levels of cells 2, 3, 4 and 5.

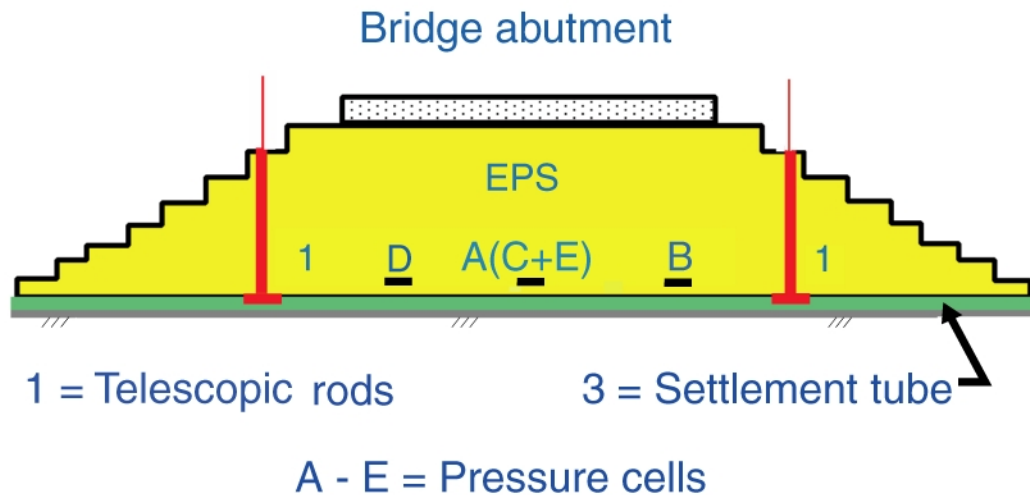
**Figure 21. Cross section indicating location of monitoring equipment**

In order to monitor the behaviour of the reconstructed bridge both settlement and stress gauges have been installed. The different types of gauges and their locations in relation to the bridge abutment are indicated on the cross section in figure 21. Prior to reconstruction the settlement rates of the adjoining fills were observed to be 100 mm/year and constant. After reconstruction the settlements have nearly been halted as shown on figure 22.
